JERSEY FIRST INSPECTION SERVICES

*** INSPECTION REPORT SUMMARY ***

CLIENT: John Smith
INSPECTION NO: 2021001234
INSPECTION DATE: 00/00/2021
INSPECTION ADDRESS: 123 New St, New Jersey

BUILDING INSPECTION REPORT

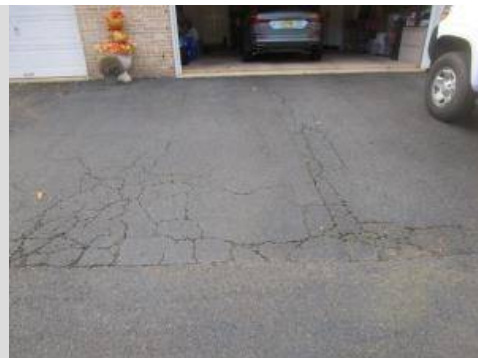
Action Needed- Cracks and surface deterioration is present. Have a contractor repair or replace.

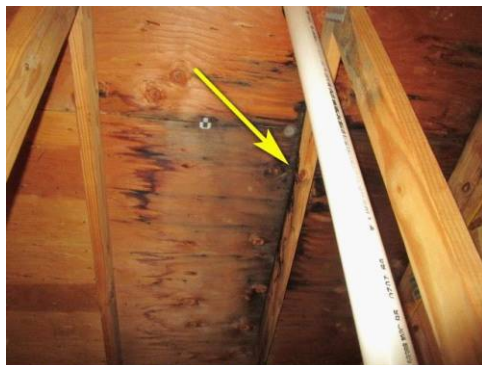
Action Needed- Neoprene vent flange/s, may have lost their tight seal around the vent pipes and may be the cause of the stains on the sheathing in the attic. Have a qualified roofing contractor repair.

Action Needed- Stains observed on roof decking and framing. See Flashings/Penetrations under Roof section.

stain from flashing leak

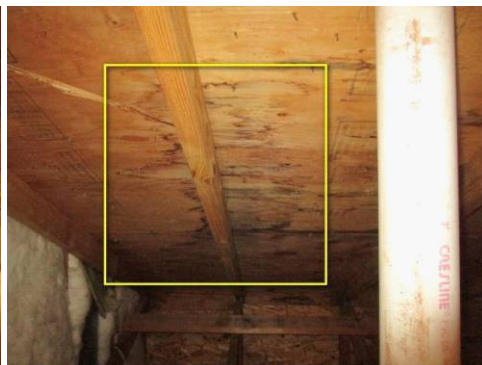
stains from flashing leak

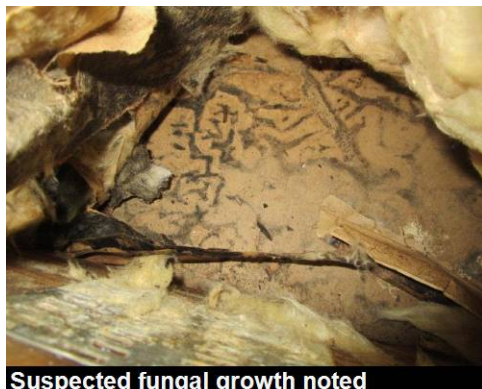
Action Needed- Suspected fungal growth noted, drywall, sheathing and framing (upper attic space and rear bedroom access above kitchen). It is recommended that a qualified/certified environmental/mold professional review and remove any and all suspected fungal growth and affected building materials (per EPA guidelines). Please be aware additional fungal growth may be present, therefore the entire home should be evaluated. The underlying problem should be identified and repaired, prior to closing.

Suspected fungal growth noted

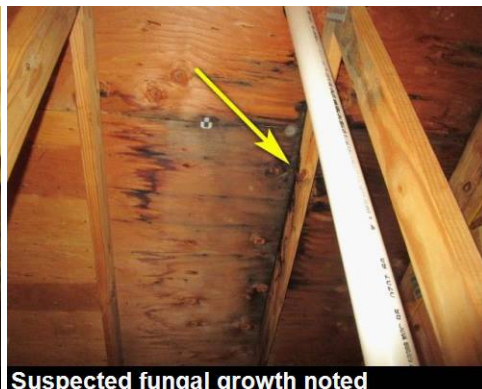
Suspected fungal growth noted

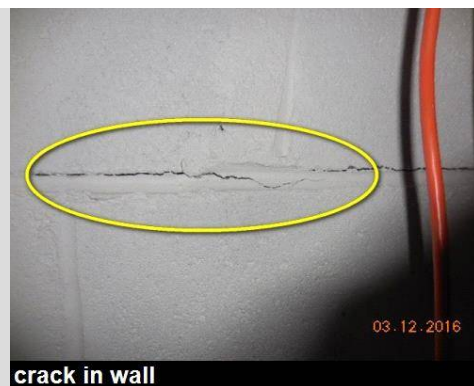
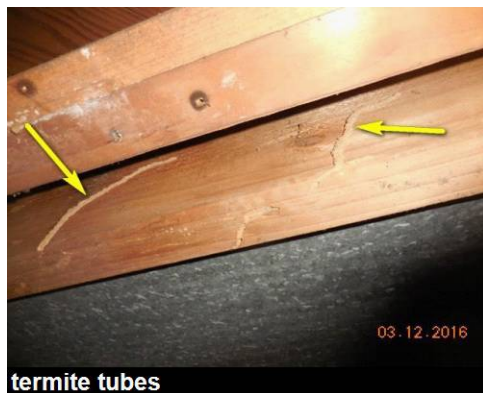
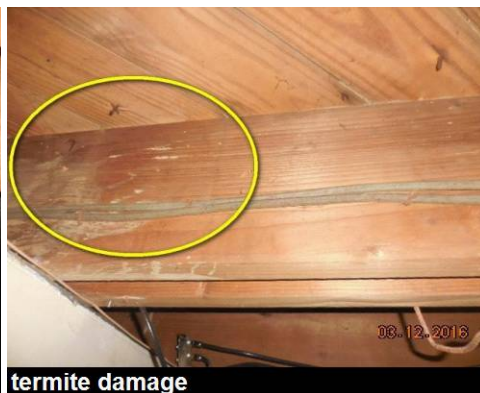
BASEMENT ACCESS:	Located @ hall.
STAIRS:	Intact and functional.
FLOOR TYPE/CONDITION:	Concrete.
WALL TYPE/CONDITION:	Block. Action Needed- Horizontal crack with bowing, left and rear walls. This is an indication that previous settlement/movement has occurred at this location. Inspector is unable to determine when settlement/movement occurred or if additional settlement/movement is likely. Have a structural engineer evaluate, provide a more detailed report and repair options.
EVIDENCE OF MOISTURE:	No signs of moisture penetration noted at time of inspection.
FLOOR JOIST TYPE/CONDITION:	Type: Conventional framing. Action Needed- Pest damage joist/s and/or termite tubes are present, Please be aware that additional latent damage to the structure of the home may exist that was not discovered during today's visual inspection of the accessible components. In order to determine if latent damage exists, it is necessary to have invasive and destructive testing and further evaluation performed by experienced/licensed contractors and specialists (prior to the expiration of your inspection contingency) to define the scope and cost of any necessary corrective action. I recommend you obtain written documentation from an expert to determine the extent of wood destroying insect damage that has occurred.

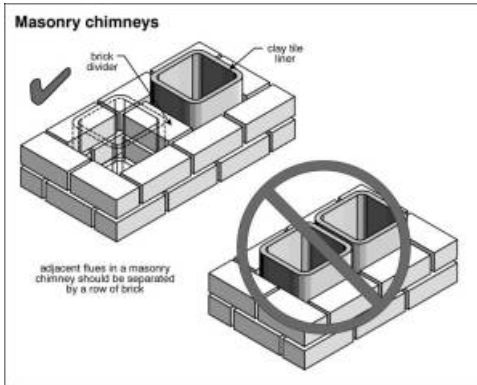
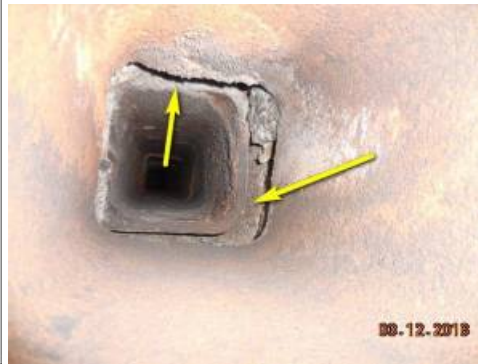
CHIMNEY TYPE/LOCATION:	Brick.
CHIMNEY/B-VENT CONDITION:	<p><i>Two or more flue caps have been installed, typically one continuous cap is installed to prevent damage to the chimney structure.</i></p> <p>Action Needed- 1). Chimney has been constructed without the proper separation between the flues. This condition can cause, water penetration and damage, cross over of heat and smoke from one flue to the other and one flue causing deterioration to the other. I recommend a level two inspection, by a certified chimney contractor, prior to closing to determine appropriate repairs and costs.</p> <p>2). Mortar is missing at clay liner joints and liner sections are missing. Building and flue gas standards state, that the flue liner shall be continuous and shall be free of cracks, gaps or damage which would allow the escape of combustion products. When an inspection reveals unsafe conditions, repair, rebuilding, lining or relining per NFPA 211 is required.</p>

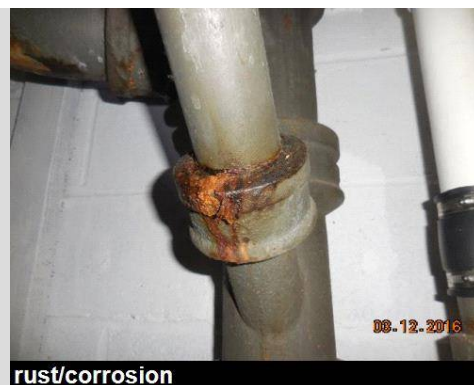
Action Needed- 1). Active leakage observed. Have a licensed plumber review and repair or replace.
2). Rust/corrosion is present at the cast iron piping. Have a licensed plumber review and repair or replace.

rust/corrosion

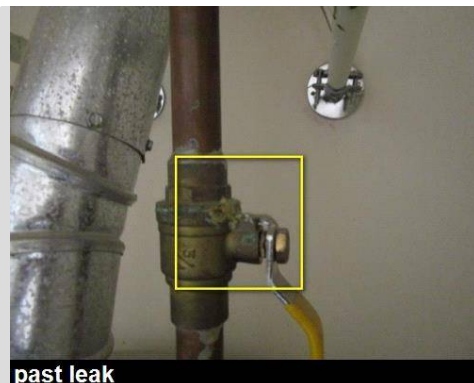
Evidence of past leakage noted. Suggest repair by a licensed plumber.

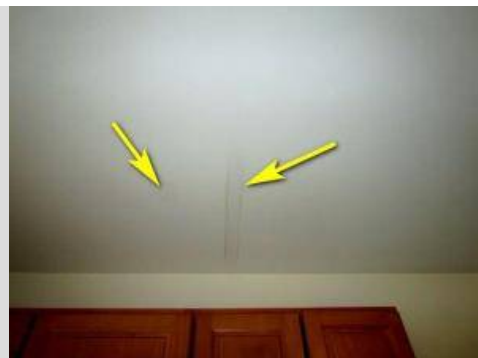
Stains are present, ceiling. See Evidence of Moisture under Attic section.

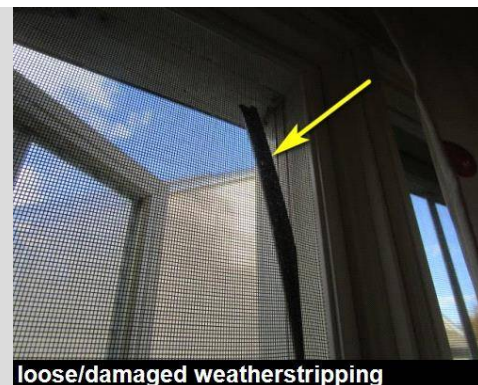
Loose/damaged weatherstripping, window above sink. Have a contractor repair.

loose/damaged weatherstripping

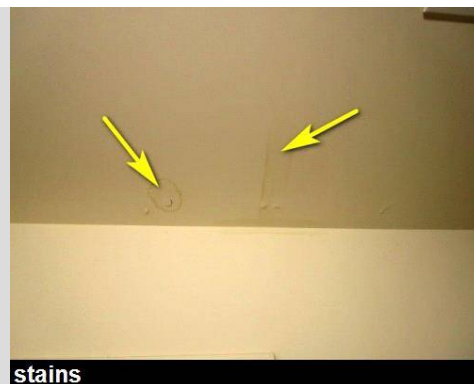
WALLS/CEILINGS: Action Needed- Stains are present, ceiling. Suggest a qualified contractor determine the cause of the stains and repair.

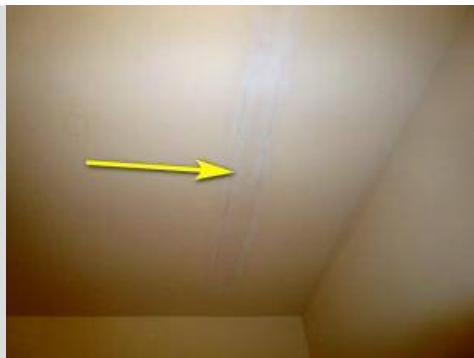
WALLS/CEILINGS: Action Needed-Stains are present, ceiling. Suggest a qualified contractor determine the cause of the stains and repair.

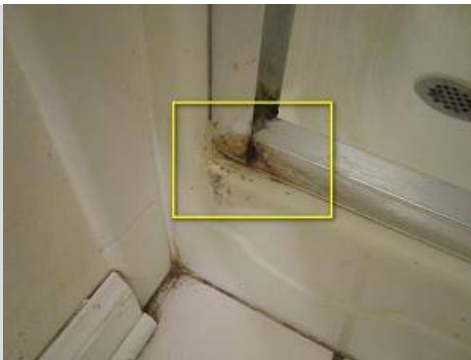
HEAT SOURCE:	Forced air register.
TUB/TUB SURROUND:	<i>Tub/wall junction and tile corners should be caulked to prevent moisture penetration. Failure to keep walls sealed can cause deterioration and moisture damage to the interior walls, which is not always visible to the inspector at the time of inspection.</i>
TUB FAUCET/STOPPER:	Functional.
SHOWER SURROUND/SHOWER BASE:	<p>1). <i>Shower stall/wall junction and tile corners should be caulked to prevent moisture penetration. Failure to keep walls sealed can cause deterioration and moisture damage to the interior walls, which is not always visible to the inspector at the time of inspection.</i></p> <p>2). <i>All loose/missing grout should be replaced and sealed to prevent moisture penetration. Failure to keep tiles sealed can cause moisture/water damage to the surfaces beneath.</i></p>
SHOWER DOOR:	<p>Action Needed- Enclosure leaks at base/wall connection. Replacement is required.</p>

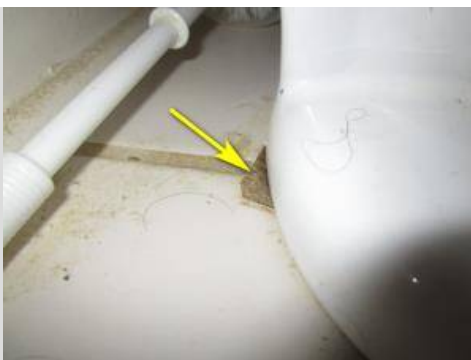
SHOWER FAUCET:	Not operated due to stored items. Suggest client verify operation, prior to closing.
SINK(S):	Functional.
SINK FAUCETS/STOPPER:	Functional.
TRAPS/DRAINS/SUPPLY LINES:	Viewing below the sink area is restricted due to homeowner stored items.
TOILET:	<p>Action Needed- Toilet rocks and a deteriorated wood shim is present. Have a licensed plumber repair.</p>

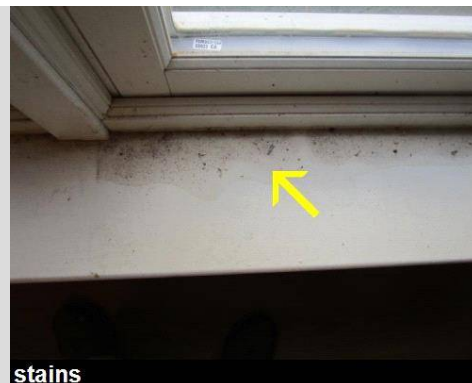
Stains noted on dining room sill, possibly due to a previous leak as a result of poorly sealed or improperly draining windows. Client is advised to consult seller to determine the source of staining and verify that corrections have been made.

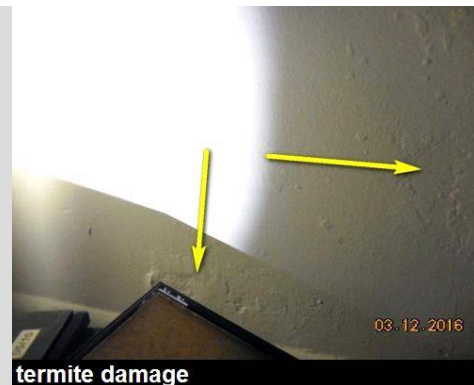
Action Needed- Termite scaring (termites have eaten the paper between the drywall and paint) observed, front right bedroom. Please be aware that additional latent damage to the structure of the home may exist that was not discovered during today's visual inspection of the accessible components. In order to determine if latent damage exists, it is necessary to have invasive and destructive testing and further evaluation performed by experienced/licensed contractors and specialists (prior to the expiration of your inspection contingency) to define the scope and cost of any necessary corrective action. I recommend you obtain written documentation from an expert to determine the extent of wood destroying insect damage that has occurred.
